Manhole Inspection Summary

Manhole # S25QQ1009MH

Location Address: **4800 ROLAND AVE**

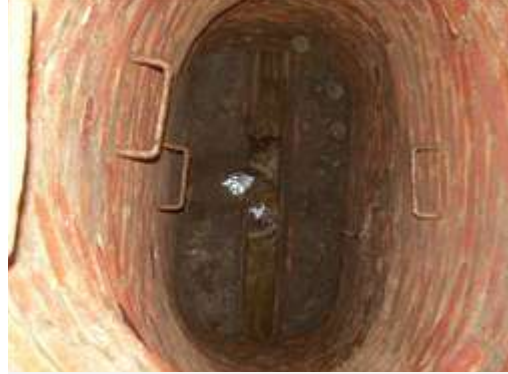
Top View

Corroded steps. Evidence of surcharge - Bench debris. Channel debris.

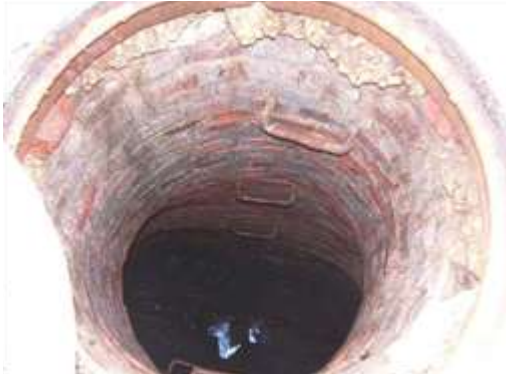
Defect

Frame offset. Adjustment deterioration, loose brick and infiltration. Barrel infiltration - other side.

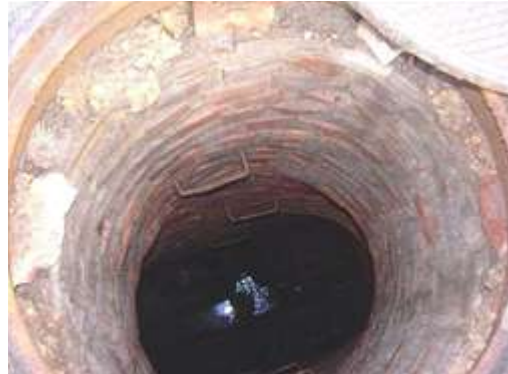
Defect

Frame offset. Adjustment deterioration, loose brick and infiltration. Barrel infiltration.

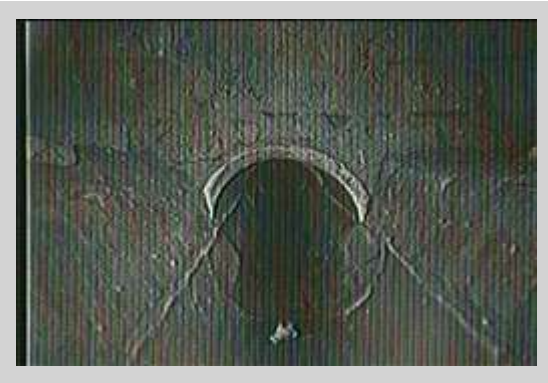
8 in. Circular Gravity Sewer Pipe Out @ 12 O'Clock

Barrel deterioration and infiltration.

Infiltration: **Evidence** Pipe Seal Cond: **Cracked**

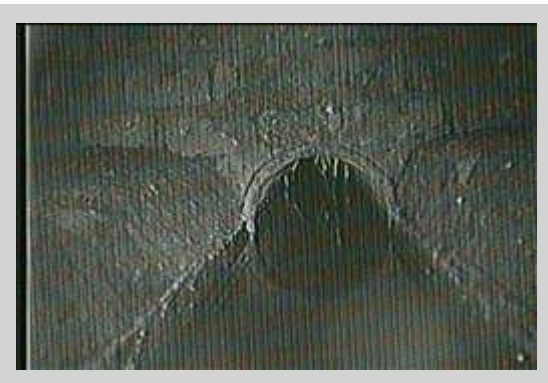
8 in. Circular Gravity Sewer Pipe In @ 6 O'Clock

Infiltration: **Evidence** Pipe Seal Cond: **Roots**
